Manhole Inspection Summary

Manhole # S41W1_023MH

Location Address: **601 Chart St**

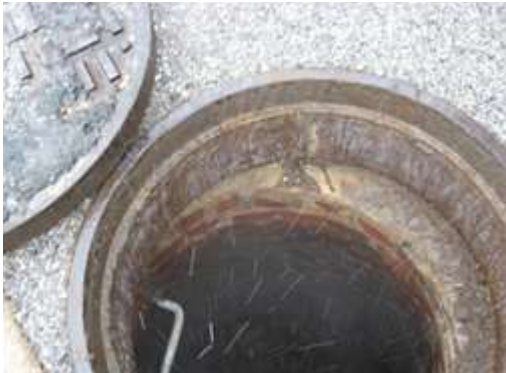
Defect 1

Offset: **2** (in.)

Frame Offset

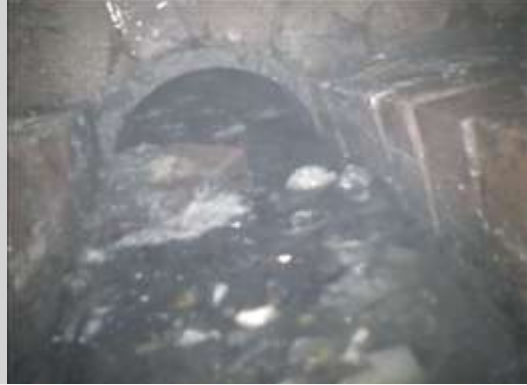
12 O'Clock Outflow

8 in. Circular Gravity Sewer
Pipe Out @ 12 O'Clock

Pipe Height: **8.4** (in.) Rod and Bar (Angled)
Pipe Material: **Clay** ☐ Pipe Lined
Invert Depth: **9.08** (ft.) Flow Characteristics: **Slow**
Deposits: ☐ None ☒ Mud ☒ Sludge ☒ Debris ☐ Grease
Silt Depth: **4** (in.) Deposits Extent: **Medium**
Infiltration: **None** Pipe Seal Cond: **Cracked**

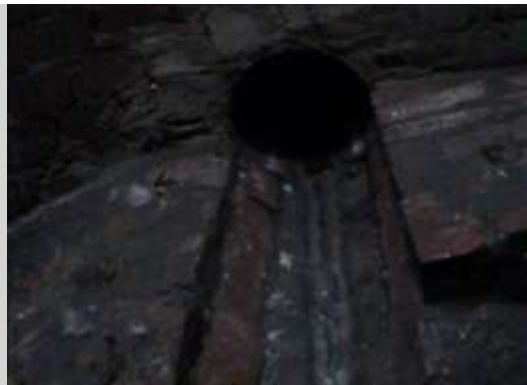
6 O'Clock Inflow

8 in. Circular Gravity Sewer
Pipe In @ 6 O'Clock

Pipe Height: **9.6** (in.) Rod and Bar (Angled)
Pipe Material: **Clay** ☐ Pipe Lined
Invert Depth: **8.46** (ft.) Flow Characteristics: **Slow**
Deposits: ☒ None ☐ Mud ☐ Sludge ☐ Debris ☐ Grease
Silt Depth: (in.) Deposits Extent:
Infiltration: **None** Pipe Seal Cond: **Cracked**

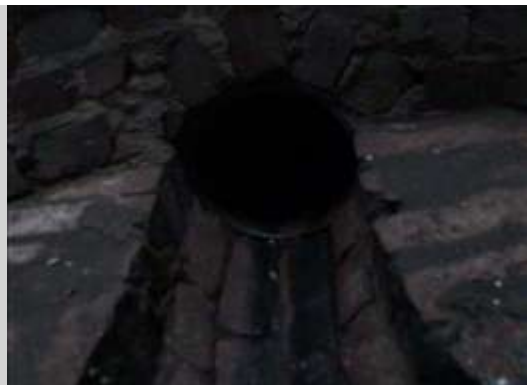
9 O'Clock Inflow

8 in. Circular Gravity Sewer

Pipe In @ 9 O'Clock

Infiltration: **None** Pipe Seal Cond: **Cracked**
